North American Society for Trenchless Technology (NASTT)
NASTT's 2013 No-Dig Show

TA-T1-05
Peninsula Light – Hale Passage Crossing

Steven K. Donovan, SHN Consulting Engineers & Geologists, Inc., Coos Bay, OR, US
Roland Johnson, SHN Consulting Engineers & Geologists, Inc. Coos Bay, OR US
Dennis Walden, Hydrometrics, Inc., formerly of Peninsula Light Company/Gig Harbor WA, US
Neil Swope, HDD Company, Cameron Park, CA, US

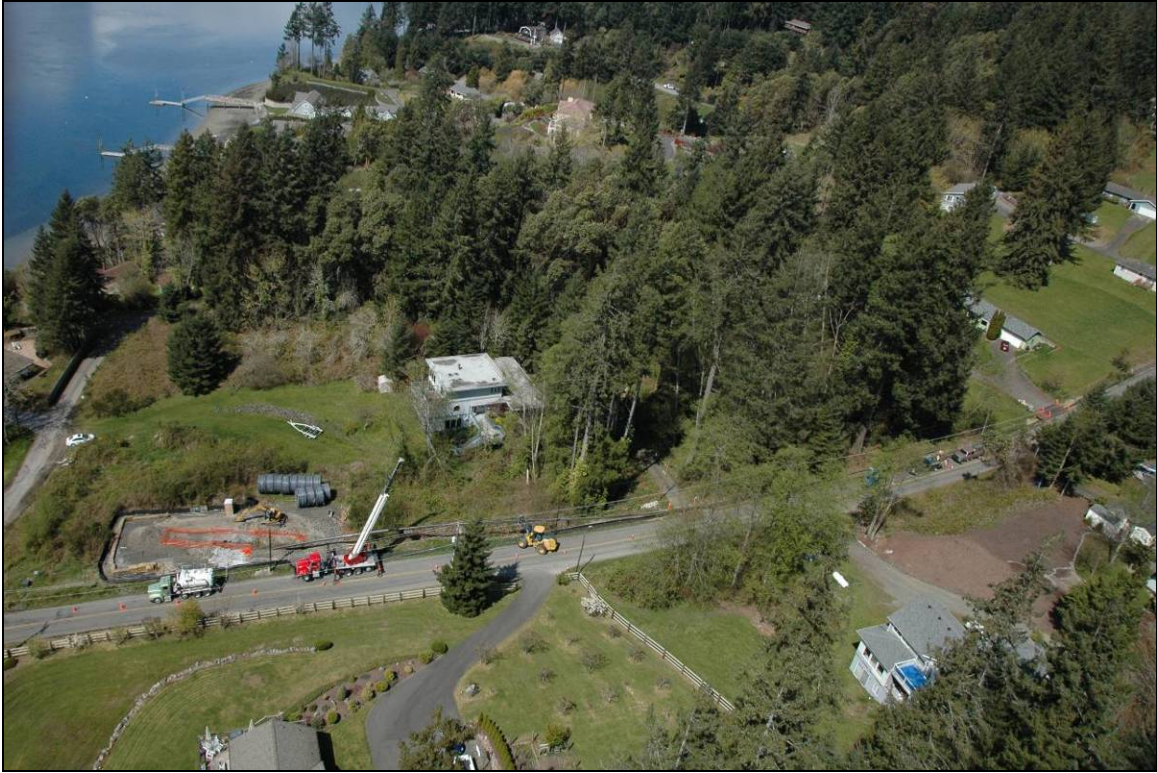
Figure 3 – HDD Exit on peninsula side

The project was configured to utilize the more rural area on the Gig Harbor Peninsula for the layout and assembly of the 12-inch casing, conduits, and cable reels while the drill rig and related HDD equipment would operate from Fox Island. This configuration would place the exit approximately 60 feet above the entry elevation and require having all fluids, cuttings, and heavy construction equipment located adjacent to the front yards of the Fox Island residents and 200 feet away from a sensitive Puget Sound tide pool. Additional area was included in the project area to allow for a drill rig set up on the peninsula side, if an intercept was determined to be necessary.

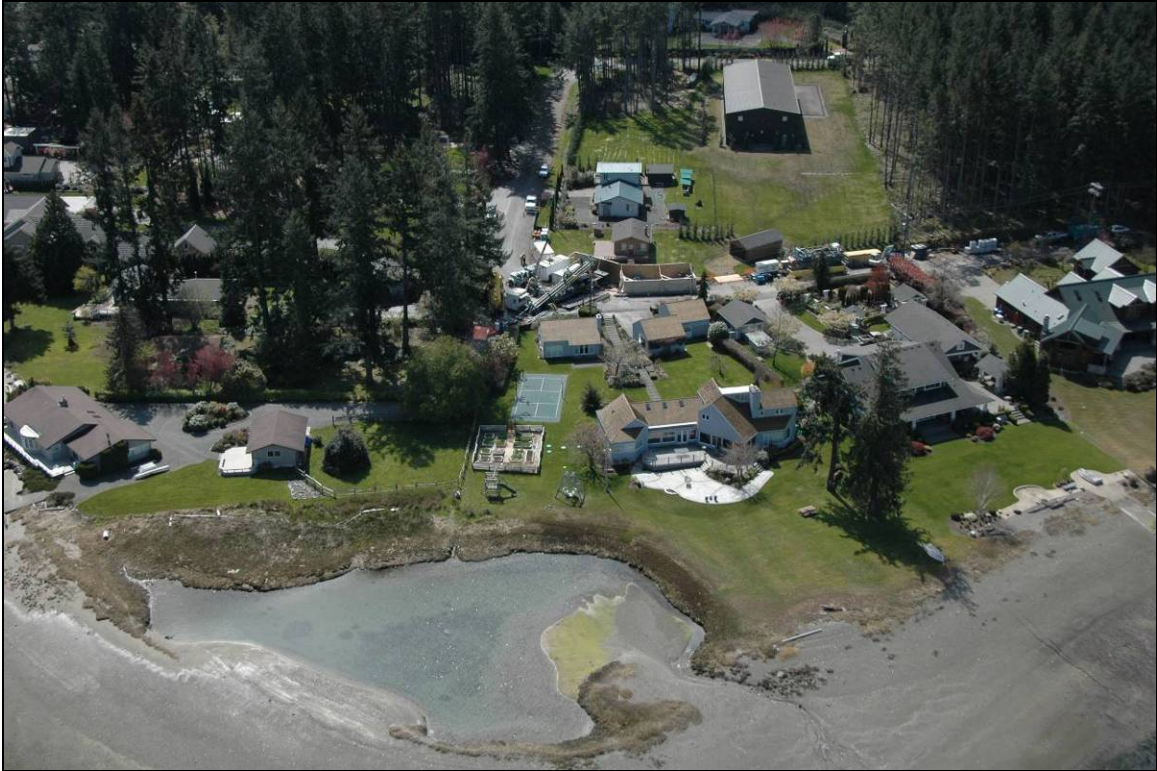
Figure 4 – HDD Entrance on Fox Island side

The Fox Island launch site was designed to reduce neighborhood inconveniences. All stationary engines and motors were required to be contained in a sound dampening enclosure and access to private property was required to be maintained at all times. Added protection was determined necessary at the entry site because the alignment crossed directly under a large Douglas Fir, a property owner's driveway access and garage, and the existing 200 foot reconfigured Fox Island feeder circuit. A conductor casing was incorporated into the design to provide the site necessary protections.

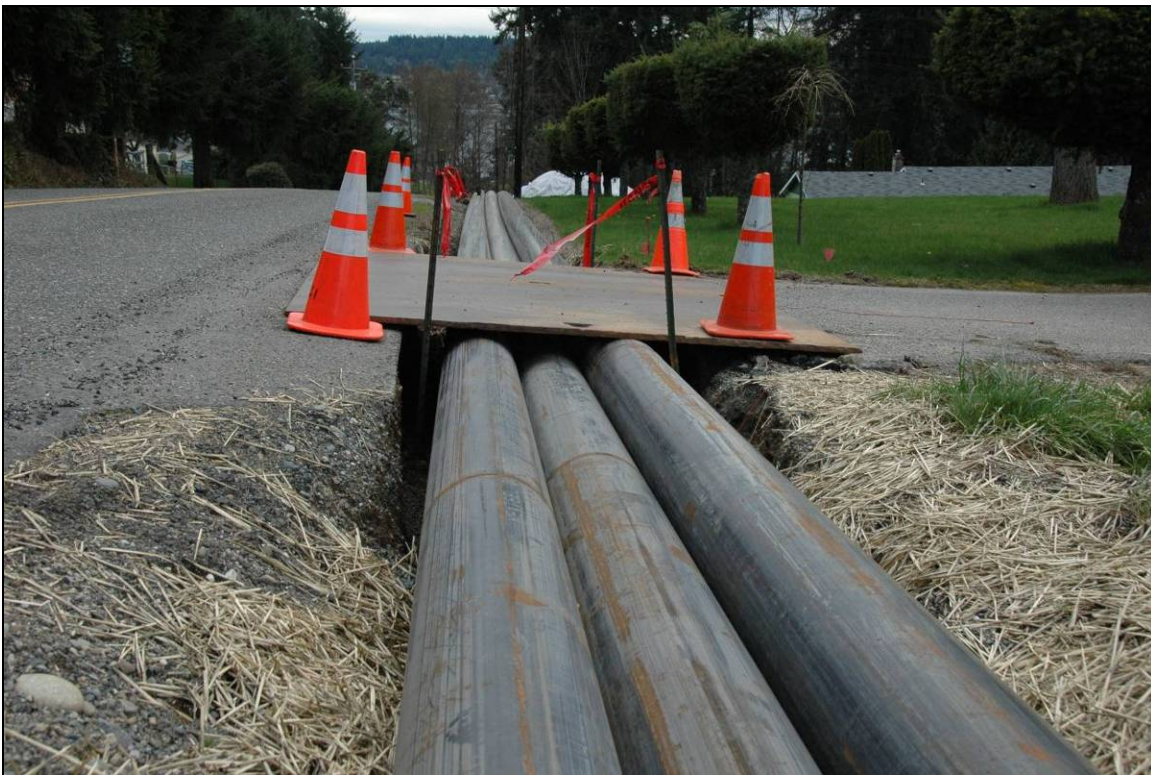
Figure 5 – Lay down of 12-inch Steel Casing

Construction commenced on February 14, 2011, with site preparation, sound panel assembly, BMP installation, and mobilization of the large array of equipment necessary for the project. The HDD Company mobilized their American Augers' 380,000 lb machine to accomplish the crossing. The steel pipe assembly was initiated first and included construction of the lay down area along 1,800 feet of Pierce County roadway. The assembled casing crossed seven driveways and required removal of several culverts and re-grading of ditches. The lay down site BMPs included installation of rock check dams, swale reconstruction, straw bale containment berms, and silt fencing.

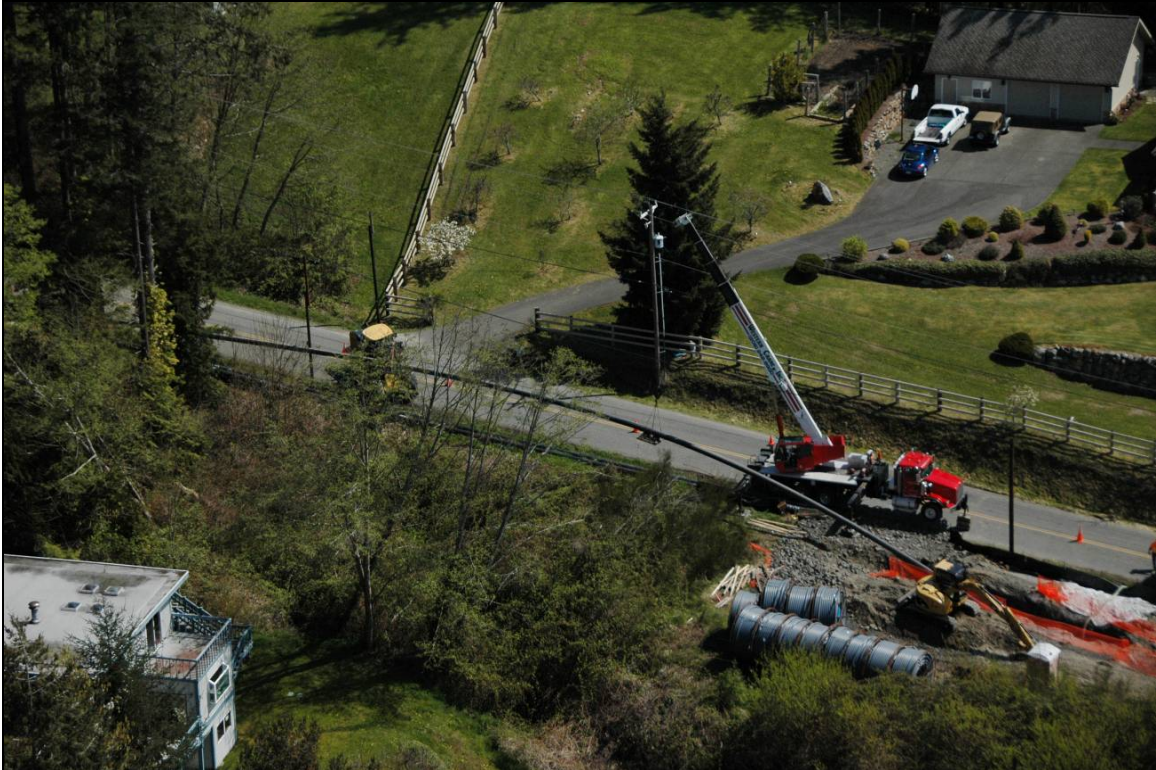
Figure 7 – Roping in Steel Casing During Pullback

After completion of the borehole, the 3,520 foot twelve-inch steel casing was pulled in three preassembled segments into the borehole from the peninsula to Fox Island. Once the casing was installed, a conduit bundle, consisting of five three-inch diameter and one two-inch diameter HDPE conduits was pulled into the casing. The conduit installation took place over six days.
